# TREE SURVEY & RISK ASSESSMENT

East Hunsbury Parish Council

**October 2022**

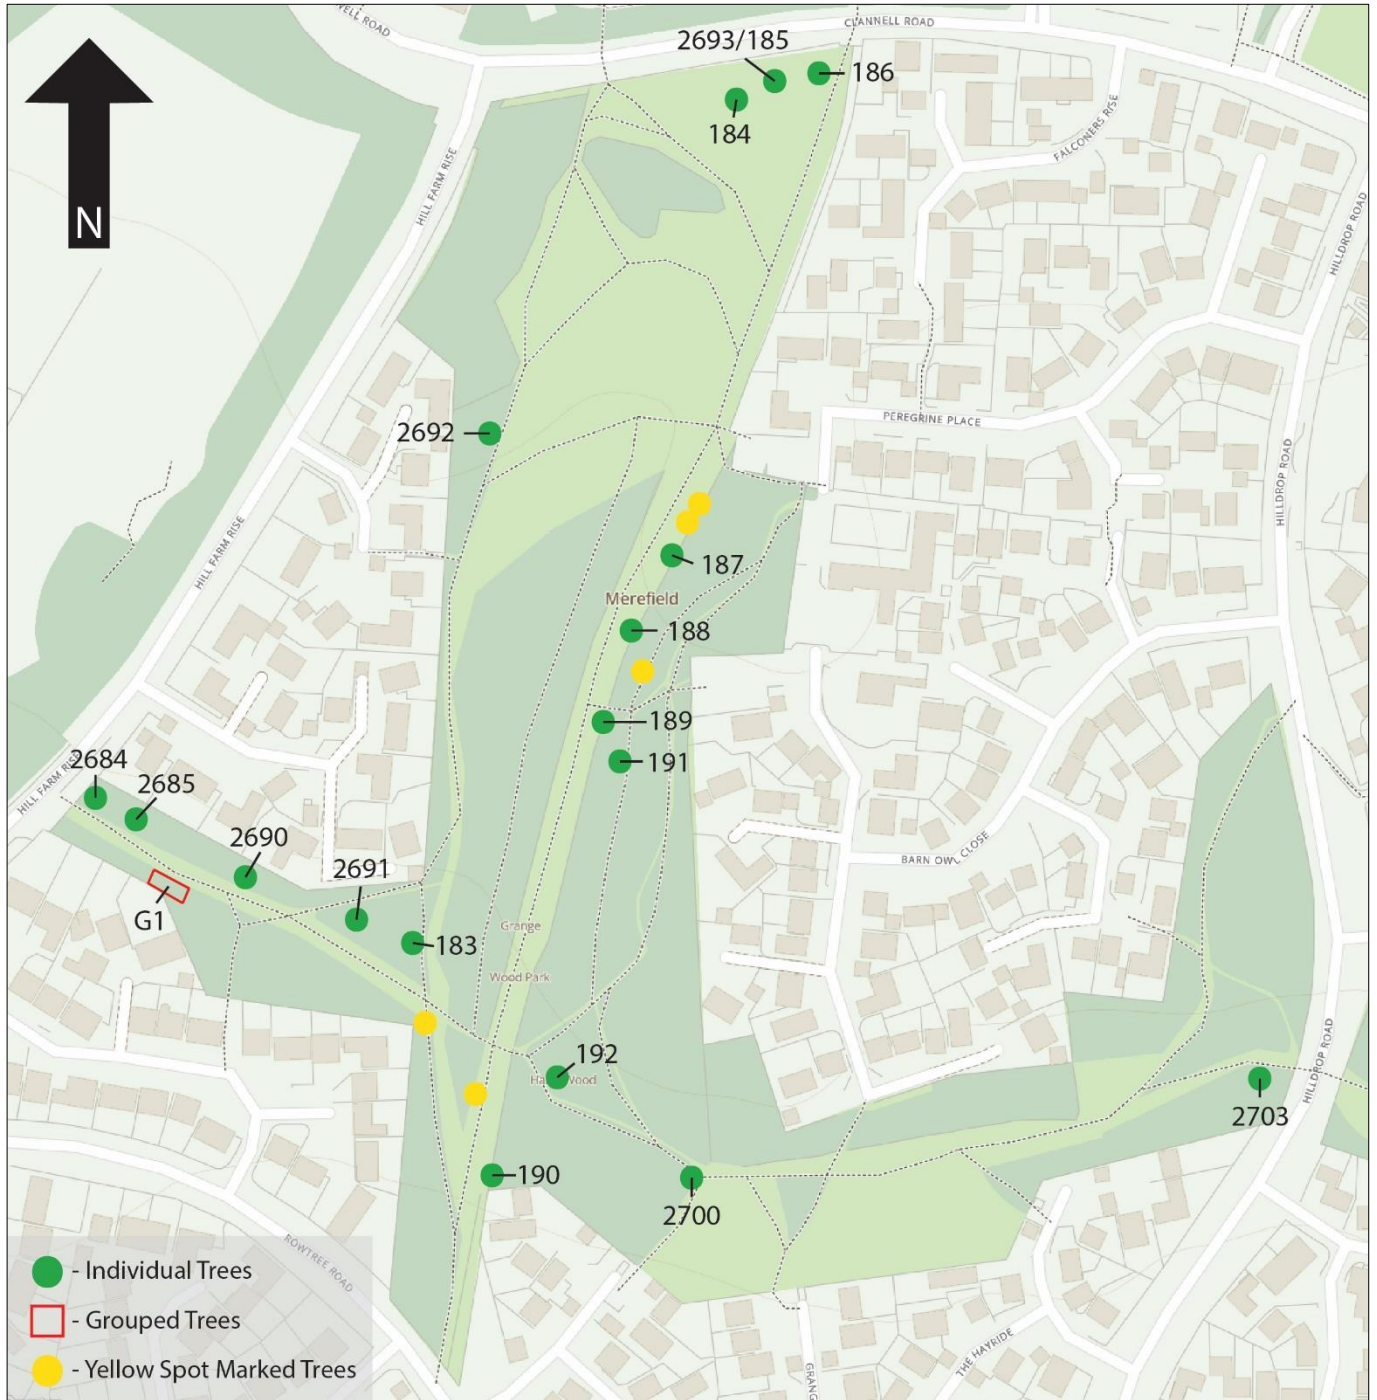
Plan 1 : Grangewood Park

Location	Tree ID.	Species (Common Name)	Age Class	Height (m)	Stem dia. (mm)	Physiological Condition	Structural Condition	Observations / Comments	Recommendations	Work Priority
Grangewood Park	183	Silver Maple	Middle aged	14	500	Normal	Good	Significant deadwood throughout crown to east over footpath	Remove all significant deadwood	Medium
	184	Silver Maple	Middle aged	13	460	Normal	Good	<i>Inonotus hispidus</i> fruiting body at 2.5m to north - sound at present	Monitor condition of tree during routine inspections	N/A
	186	Ash	Middle aged	13	380	Normal	Fair	Weak compression fork at 2m with included bark	Remove to ground level	Medium
	187	Ash	Mature	15	450 400	Fair	Poor	Co-dominant main stem to northwest has significant lean to northwest over footpath, with partial fracture at source/basal union	Remove co-dominant stem to northwest to source	High
	188	Ash	Middle aged	13	450	Fair	Poor	<i>Inonotus hispidus</i> fruiting body at 3m on main stem. Low vitality throughout crown/in decline	Remove to ground level	High

189	Hawthorn	Middle aged	8	220	Poor	Poor	Dead tree fallen into adjacent tree, located adjacent to footpath	Remove dead Hawthorn to ground level	Medium
	190	English Oak	Mature	20	1100	Normal	Good	Ivy throughout crown – unable to fully inspect. Tree located adjacent to 3rd party property and footpath	Sever Ivy at base	Low
	191	Ash	Mature	20	500	Normal	Fair/Poor	Moderate basal decay, adjacent to footpath	Reduce height to 8m habitat monolith	Medium
	192	Ash	Middle aged	22	520	Normal	Poor	Moderate basal decay, adjacent to footpath	Reduce height to 8m habitat monolith	Medium
	2684	Ash	Middle aged	19	400	Normal	Good	Ivy clad throughout crown – unable to fully inspect. Significant deadwood within lower crown to south over footpath / park entrance	Sever Ivy at base Remove all significant deadwood	Medium

Location	Tree ID.	Species (Common Name)	Age Class	Height (m)	Stem dia. (mm)	Physiological Condition	Structural Condition	Observations / Comments	Recommendations	Work Priority
Grangewood Park	2685	Common Alder	Young	9	250	Fair	Fair	Crown in moderate decline (terminal)	Remove to ground level	Medium
	2690	Ash	Middle aged	19	500	Normal	Good	Significant deadwood within lower crown to south over footpath	Remove all significant deadwood	Medium
	2691	Silver Birch	Middle aged	16	280	Fair	Fair	Significant deadwood throughout crown	Remove all significant deadwood	Medium
	2692	Ash	Middle aged	15	530	Normal	Good	Significant deadwood throughout crown	Remove all significant deadwood	Medium
	2693 (185)	Ash	Middle aged	11	550	Normal	Fair	Historic failure wounds throughout crown (not occluded). Poor form. Hanging deadwood throughout crown	Remove to ground level	Medium
	2700	Ash	Middle aged	25	550	Normal	Fair	<i>Inonotus hispidus</i> fruiting body found on ground under tree. Likely to have come from area on main stem at 2.5m to east with associated staining. Tree located immediately adjacent to footpath	Undertake detailed Resistograph decay detection tests and provide further recommendations	Medium

2703	Ash	Mature	25	1100	Normal	Fair	Ivy clad up to 12m – unable to fully inspect main stem up to 12m. Significant deadwood throughout crown over informal footpath to north. Recent catastrophic limb failure to south	Sever Ivy at base Remove all significant deadwood to north over informal footpath	Medium
	G1	Scots Pine x 4	Middle aged	12	350	Poor	Poor	Dead standing trees within falling distance to footpath to north	Remove all trees to ground level	High
	N/A								5no. Trees spot marked with yellow eco paint that have significant deadwood within their crowns over footpaths throughout park (see plan for locations)	Remove all significant deadwood from yellow spot marked trees

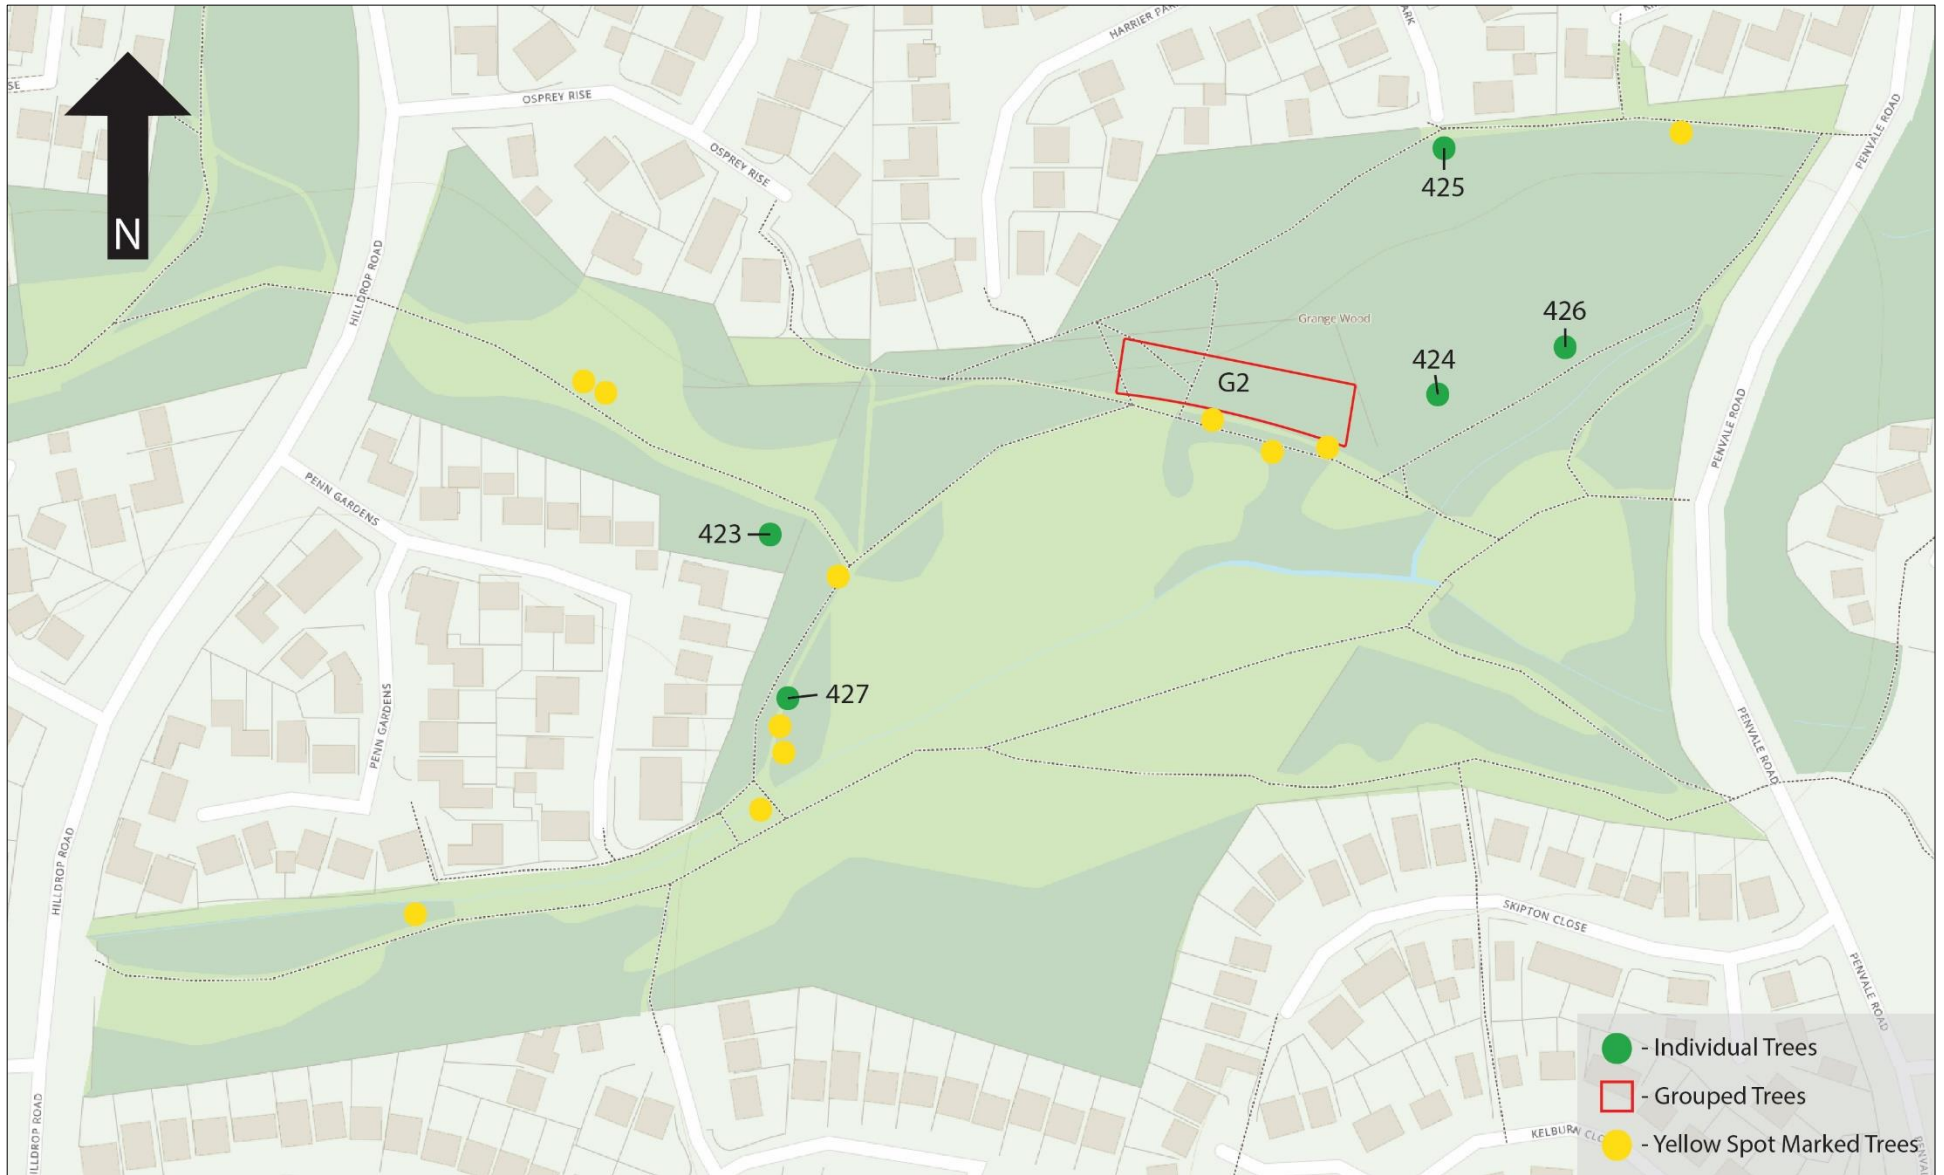
## Plan 2 : Penvale Park

Location	Tree ID.	Species (Common Name)	Age Class	Height (m)	Stem dia. (mm)	Physiological Condition	Structural Condition	Observations / Comments	Recommendations	Work Priority	
Penvale Park	423	Scots Pine	Young	14	220	Poor	Fair	In terminal decline within falling distance to footpath	Remove to ground level	Medium	
	424	Narrow leaved Ash	Mature	19	420	Normal	Fair	Recent catastrophic limb failure leaving remaining crown with poor form/no central leading stem	Remove to ground level	Medium	
	425	Norway Maple	Mature	13	470	Normal	Fair	Minor split/fracture to union at 2m	Reduce crown by 3m overall	Medium	
	426	Narrow leaved Ash	Mature	15	380	Normal	Good	Failed hanging branch at 11m to north (unstable)	Remove failed hanging limb at 11m	Medium	
	427	Silver Birch	Middle aged	16	240	Poor	Poor	Dead standing tree adjacent to footpath	Remove to ground level	High	
	G2	Ash	Middle aged	18	150	Normal	Fair	Various drawn and slender dead trees within falling distance to footpath to southeast	Remove all dead trees to ground level that are within falling distance to footpath	Medium

N/A								11no. Trees spot marked with yellow eco paint that have significant deadwood within their crowns over footpaths throughout park (see plan for approx. locations)	Remove all significant deadwood from yellow spot marked trees	Medium
	N/A								Difficulty inspecting woodland on southern boundary of park (north of Buckingham Close) - no apparent access to woodland	No action required	N/A

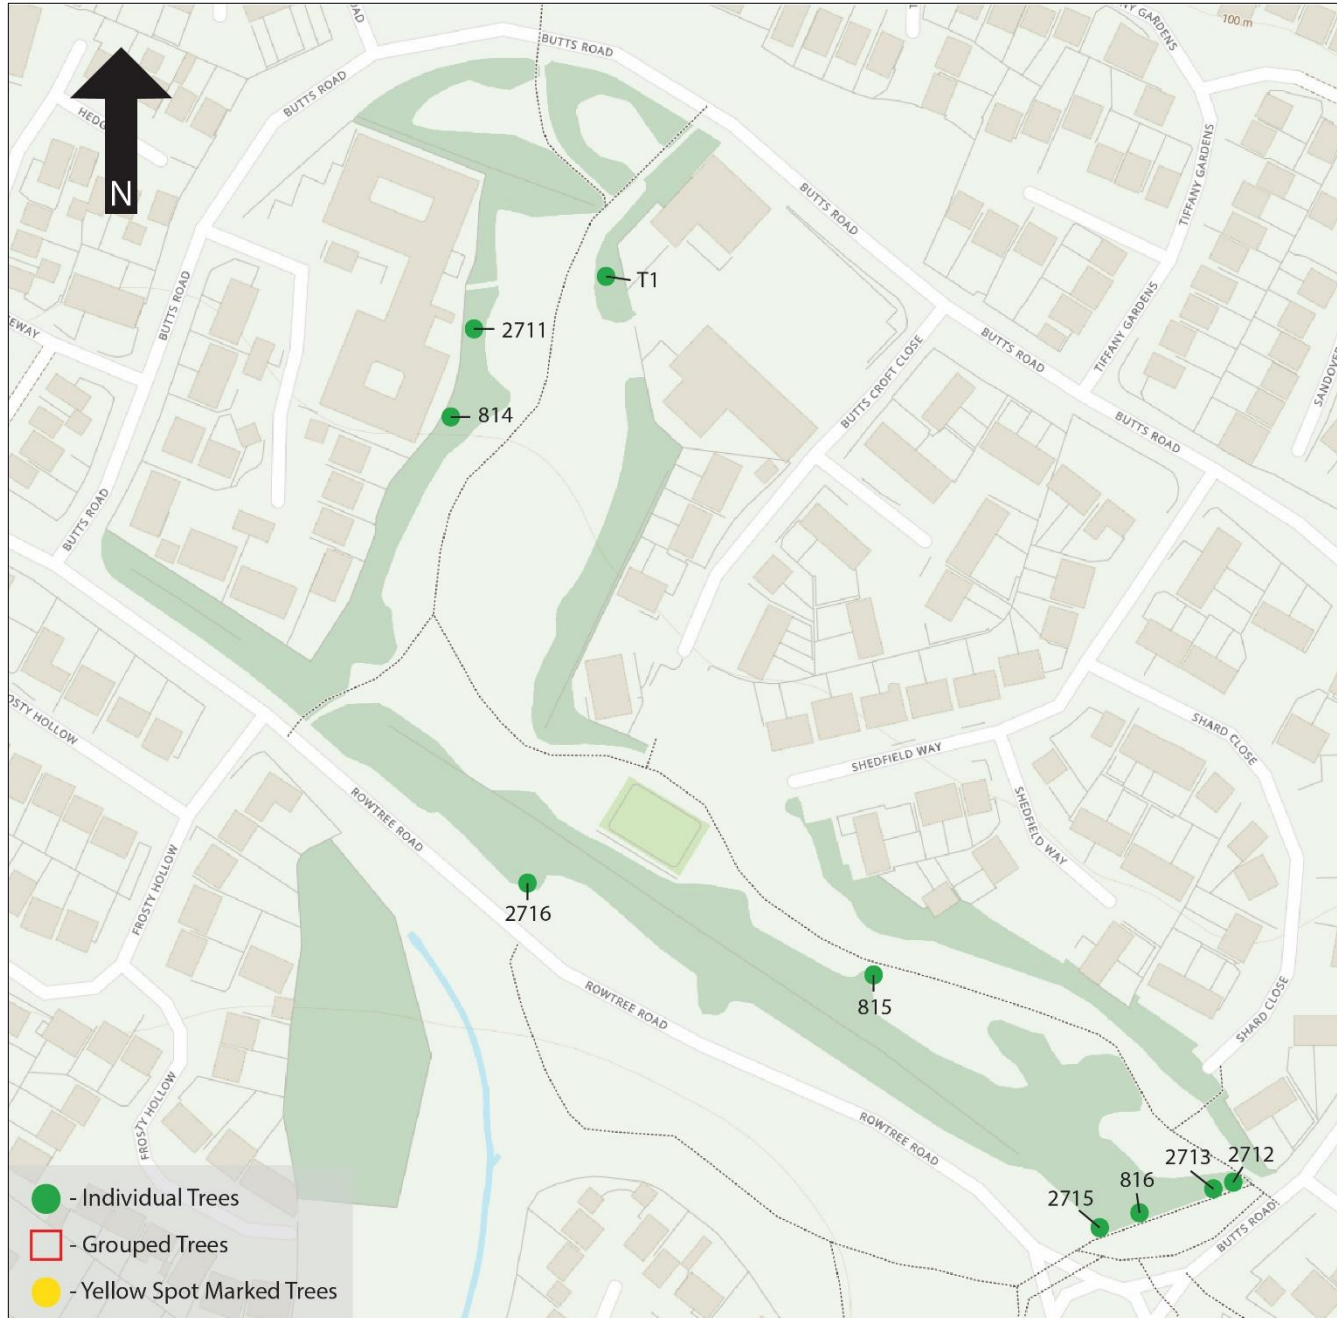
### Plan 3 : Blacky More

Location	Tree ID.	Species (Common Name)	Age Class	Height (m)	Stem dia. (mm)	Physiological Condition	Structural Condition	Observations / Comments	Recommendations	Work Priority
Blacky More Open Space	T1	Scots Pine	Young	6	200	Poor	Poor	Dead standing tree. Unable to tag due to shrubbery under tree	Remove to ground level	Low
	2711	Wild Cherry	Mature	11	550	Normal	Good	Ivy clad throughout crown – unable to fully inspect	Sever Ivy at base	Medium
	2712	Silver Maple	Mature	20	520	Normal	Good	Hanging deadwood throughout crown - over footpath	Remove all hanging deadwood	Low
	2713	Ash	Young	13	300	Normal	Good	Significant deadwood throughout crown over footpath	Remove all significant deadwood	Medium
	2715	Silver Maple	Mature	20	800	Normal	Fair	Multi-stemmed from base. Ivy clad throughout lower crown – unable to fully inspect base or lower stem. Over extended crown growth due to competition for light with neighbouring trees. Wide spread form over footpath	Reduce crown overall by 4m	Medium

2716	Silver Maple	Mature	19	500	Fair	Fair	Significant deadwood within upper crown / moderate decline throughout upper crown	Remove all significant deadwood to suitable growth points within upper crown	Low
	814	Wild Cherry	Mature	14	480	Normal	Good	Ivy throughout crown – unable to fully inspect	Sever Ivy at base	Low
	815	Norway Maple	Middle aged	10	330	Normal	Fair	Recent main stem failure, poor form to crown	Remove to ground level	Low
	816	Silver Maple	Mature	18	480	Normal	Fair	Large unmaintained crown/over-extended growth over footpath	Reduce crown overall by 4m	Low
Granary Road East	No significant defects found within area / No action required

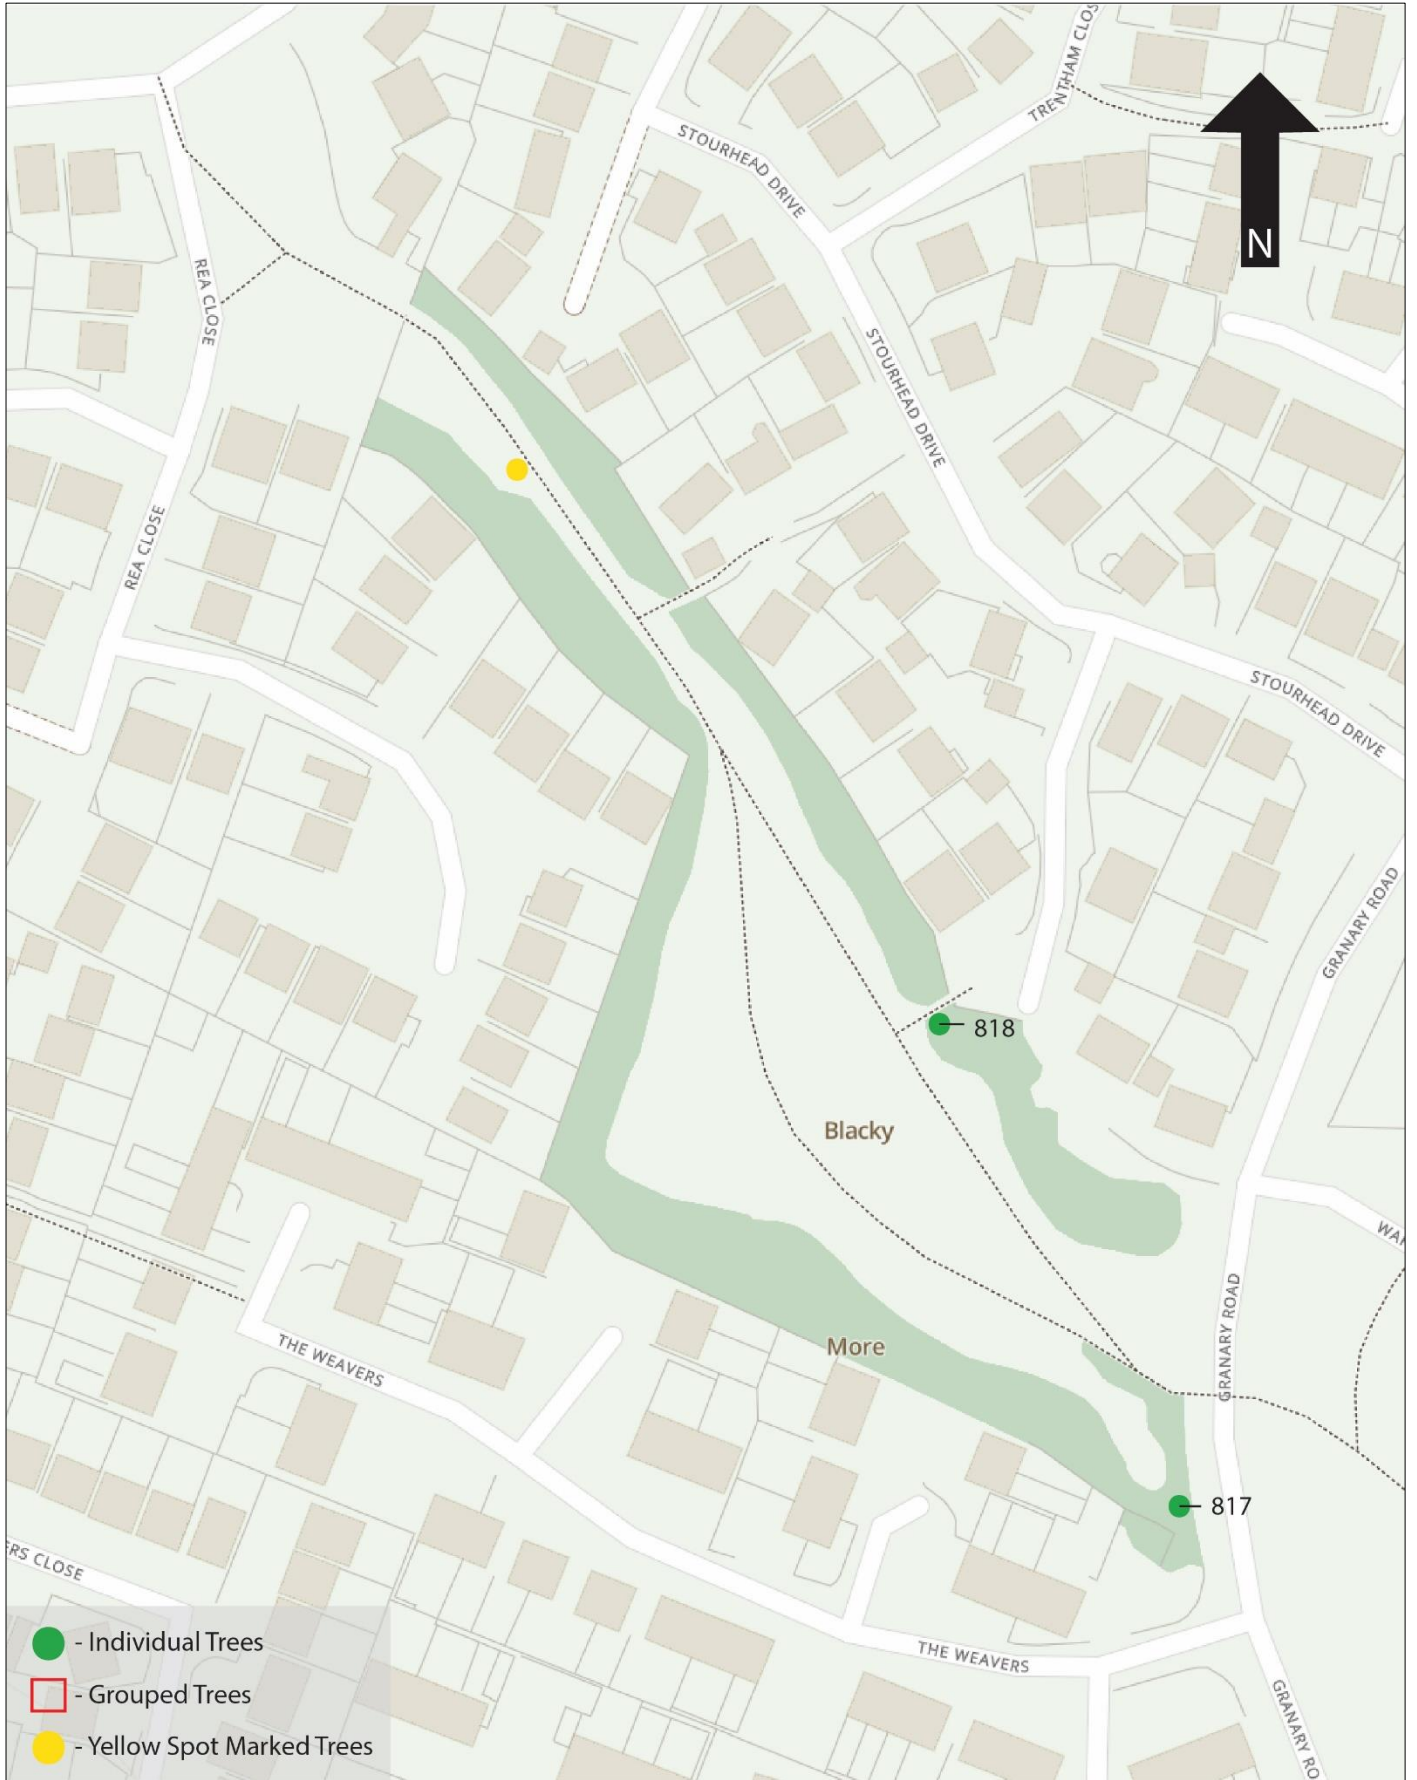
# Granary Road (West)

Location	Tree ID.	Species (Common Name)	Age Class	Height (m)	Stem dia. (mm)	Physiological Condition	Structural Condition	Observations / Comments	Recommendations	Work Priority
Granary Road West	817	Crab Apple	Middle aged	6	100	Poor	Poor	Dead standing tree adjacent to public footpath	Remove to ground level	Medium
	818	Elder	Middle aged	5	Avg. 130	Poor	Poor	Dead standing tree adjacent to footpath	Remove to ground level	Medium
	N/A							1no. Tree spot marked with yellow eco paint that has significant deadwood within its crown over footpath (see plan for approx. location)	Remove all significant deadwood from yellow spot marked tree	Medium
Stonepit Open Space	N/A							Small number of dead standing trees within area - currently very low/minimal targets	No action required	N/A
