TREE SURVEY & RISK ASSESSMENT

East Hunsbury Parish Council

October 2023

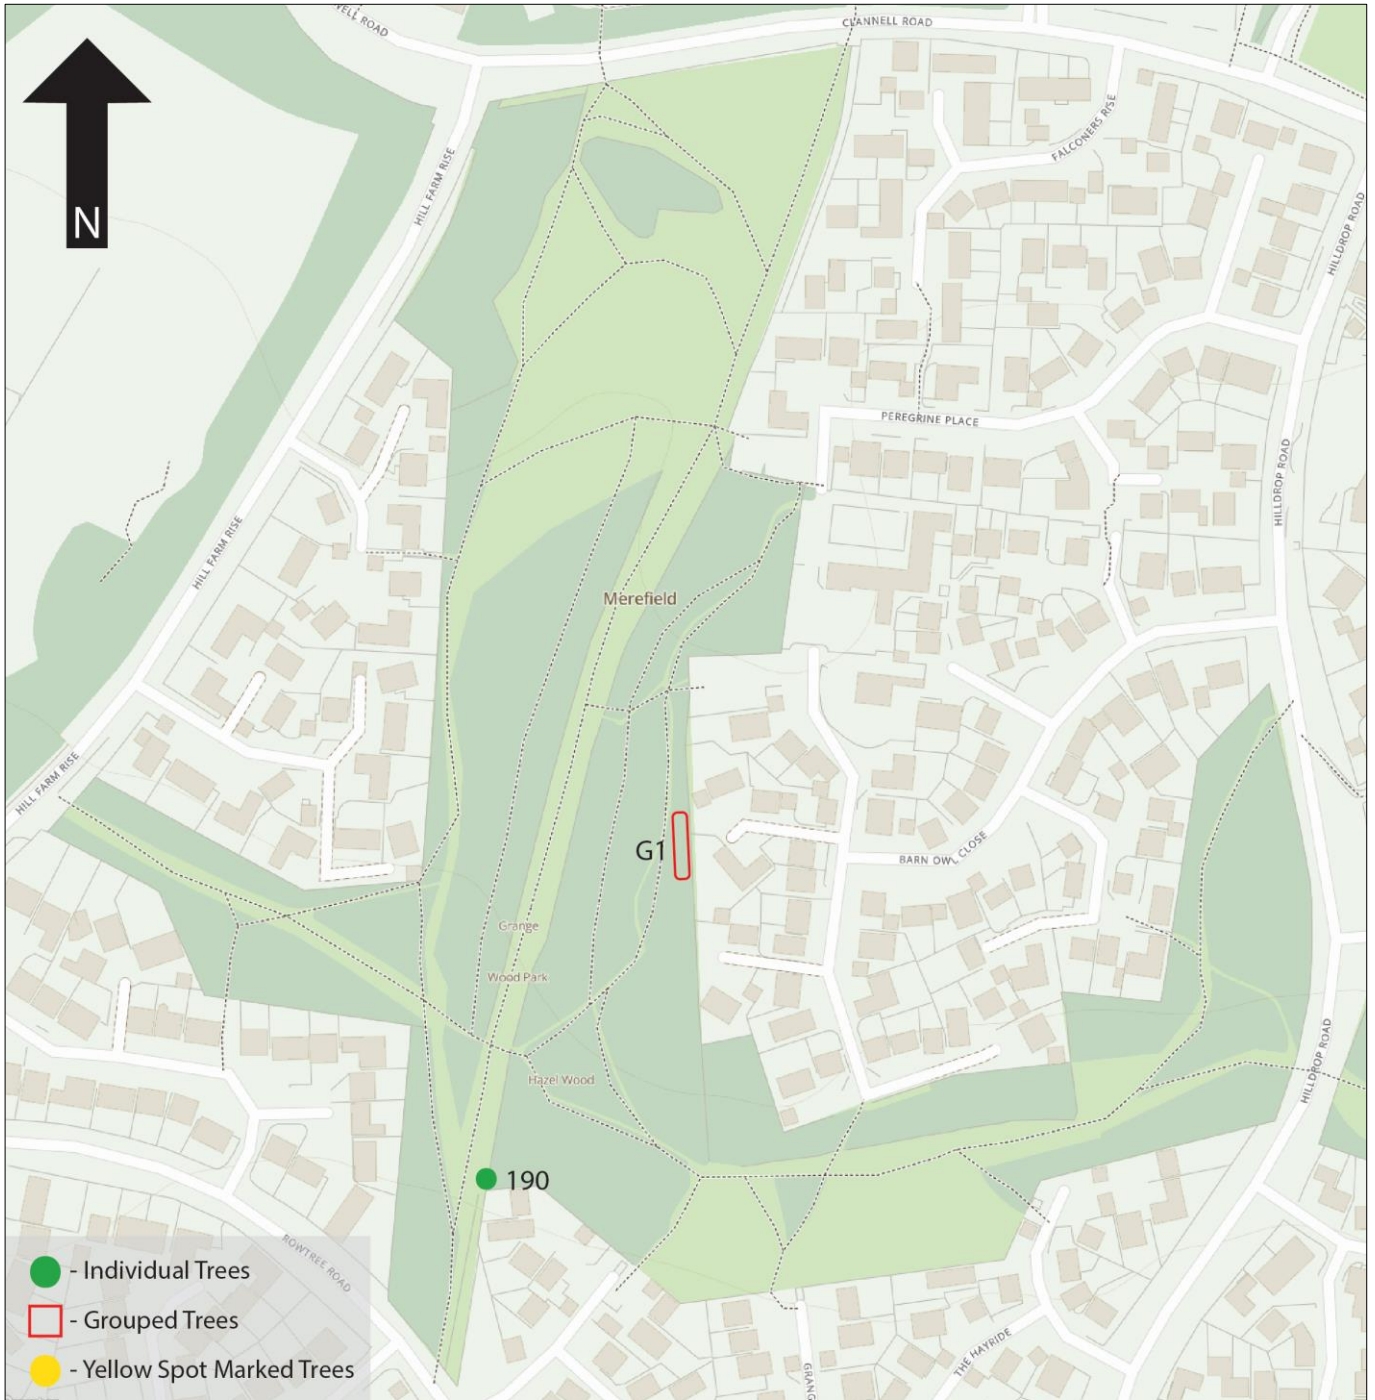
Plan 1 : Grangewood Park

Location	Tree ID.	Species (Common Name)	Age Class	Height (m)	Stem dia. (mm)	Physiological Condition	Structural Condition	Observations / Comments	Recommendations	Work Priority
Grangewood Park	G1	Sycamore	Middle aged	12	320	Poor	Poor	5 x Dead standing trees within falling distance to adjacent properties (All trees spot marked with orange eco paint)	Remove 5 x dead standing trees to ground level	HIGH
	190	English Oak	Mature	25	1200	Fair	Good	Ivy recently severed - still cannot fully inspect crown due to remaining Ivy coverage. <i>Fistulina hepatica</i> fungal fruiting body at base to south - insignificant at present	No action required	N/A
Penvale Park	1141	Ash	Mature	20	480	Normal	Fair	1 x Limb to north appears overextended towards adjacent property. Limb is mostly Ivy clad	Reduce overextended limb to north by 5m Sever Ivy at base	Low
	1142	Grey Poplar	Mature	25	580	Normal	Fair	Moderate lean to east towards footpath and properties	Reduce crown overall by 40% + remove deadwood	Medium
