## FLOOD INVESTIGATION REPORT

### EAST HUNSBURY NORTHAMPTON

27<sup>th</sup> MAY 2018

Reference: 18/30621

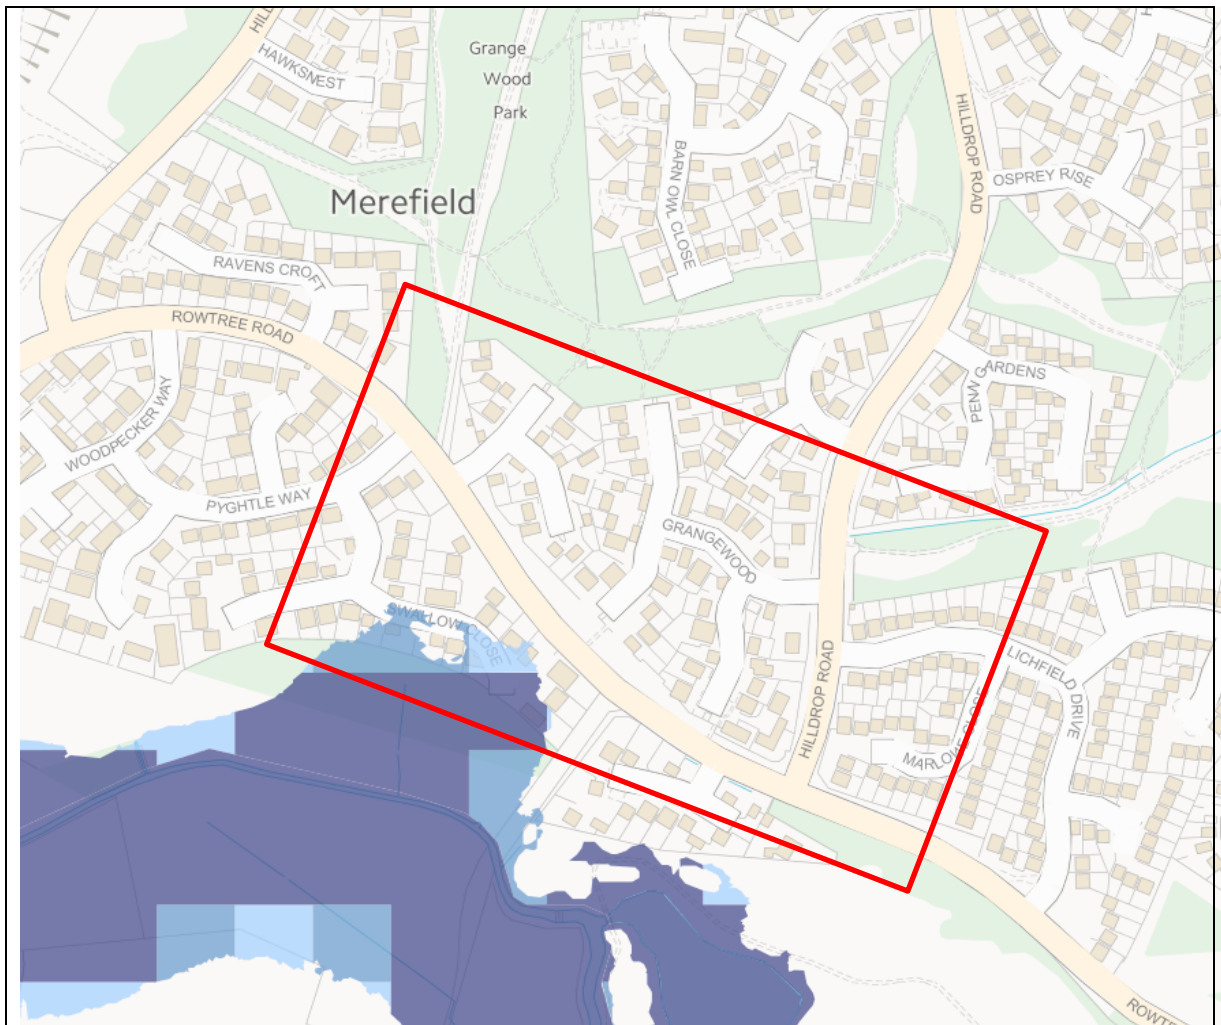
#### 4.1.3.4 Flood Risk from Rivers or the Sea

<p>This is in an area that has a <b>HIGH</b> chance of flooding from rivers. This means that each year, this area has a chance of flooding of greater than 1 in 30 (3.3%).</p>
	<p>This is an area that has a <b>MEDIUM</b> chance of flooding from rivers. This means that each year, this area has a chance of flooding of between 1 in 100 (1%) and 1 in 30 (3.3%).</p>
	<p>This is an area that has a <b>LOW</b> chance of flooding from rivers. This means that each year, this area has a chance of flooding of between 1 in 1000 (0.1%) and 1 in 100 (1%).</p>
	<p>This is an area that has a <b>VERY LOW</b> chance of flooding from rivers. This means that each year, this area has a chance of flooding of less than 1 in 1000 (0.1%).</p>

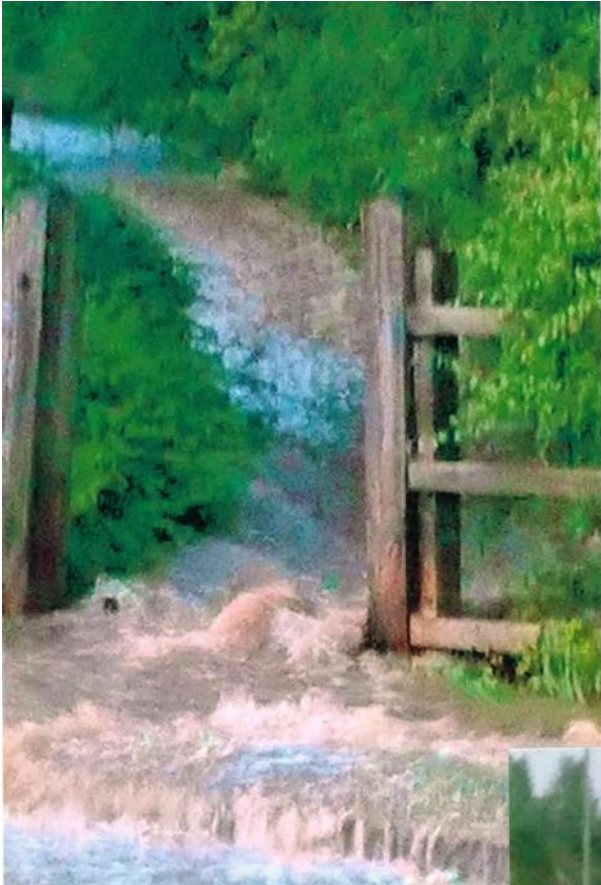
Grangewood Park

- 7.1.1.2 The blockage to the culvert from the watercourse in Grangewood Park prevented the intended flow beneath Rowtree Road. This led to a significant build-up of water at this location that overflowed onto Rowtree Road, exacerbating the conditions.

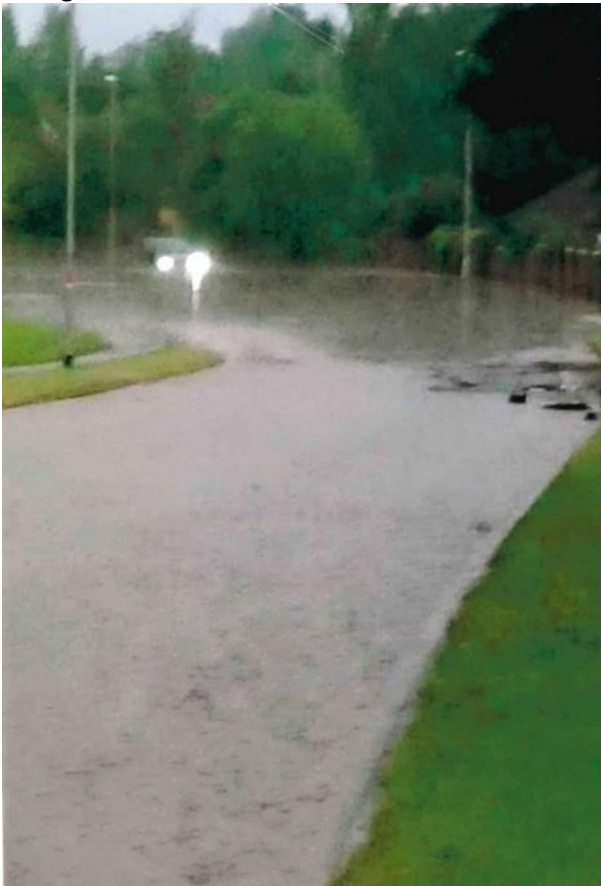
Rowtree Road

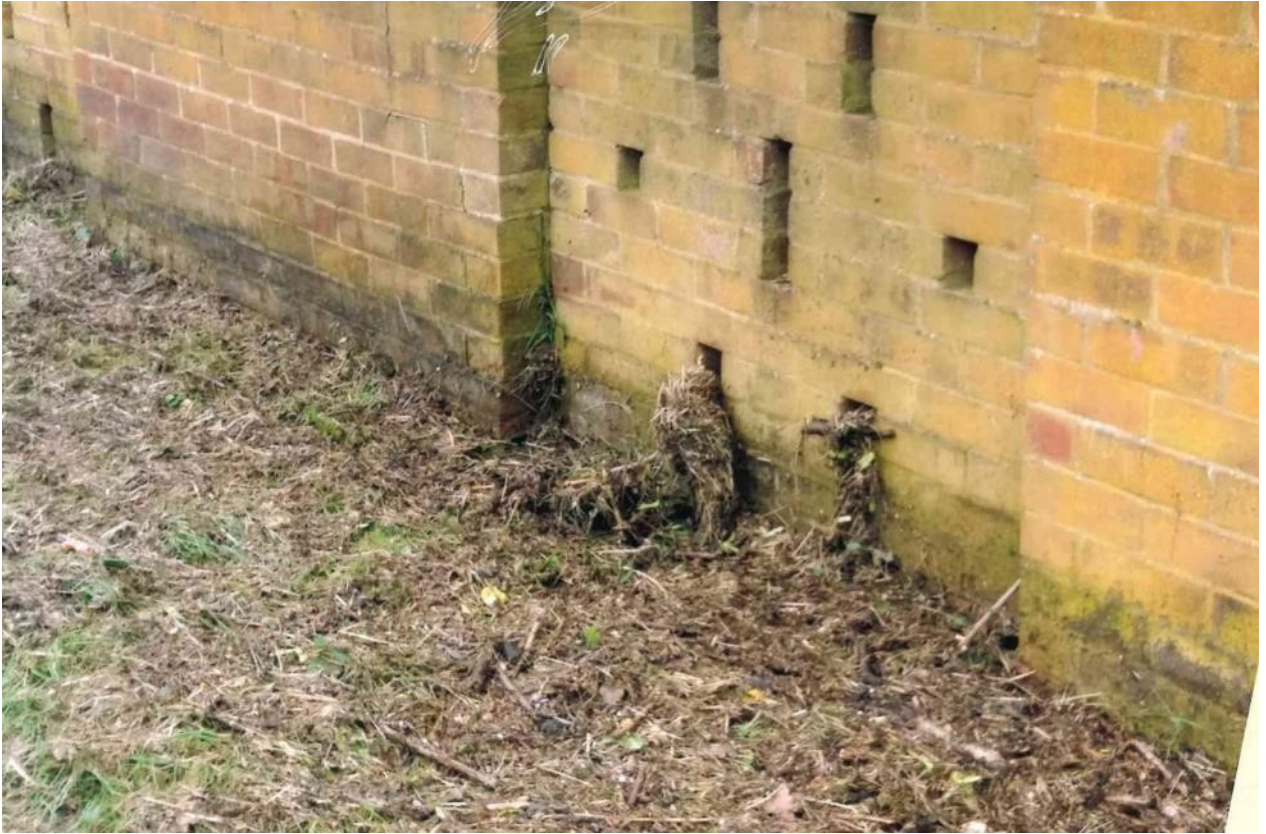
Wall to rear of Swallow Close

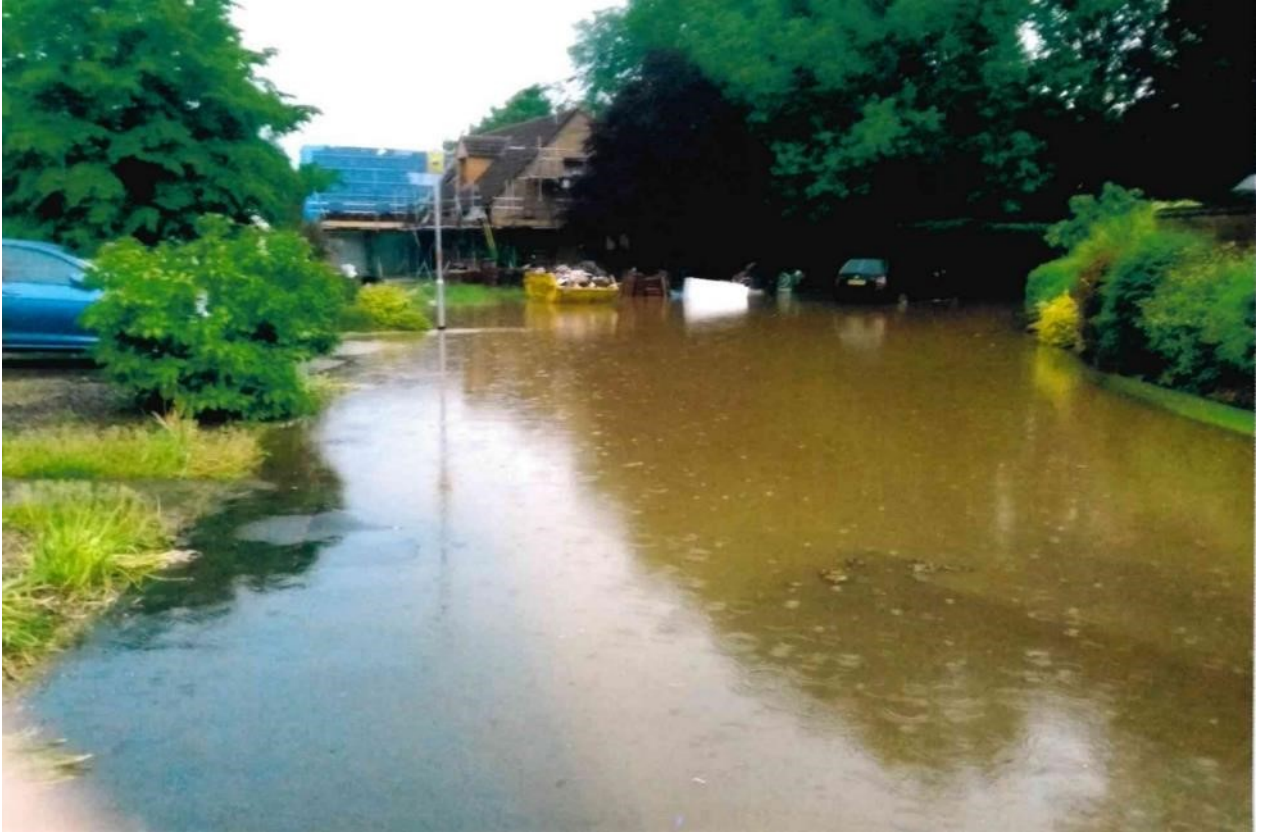
Swallow Close

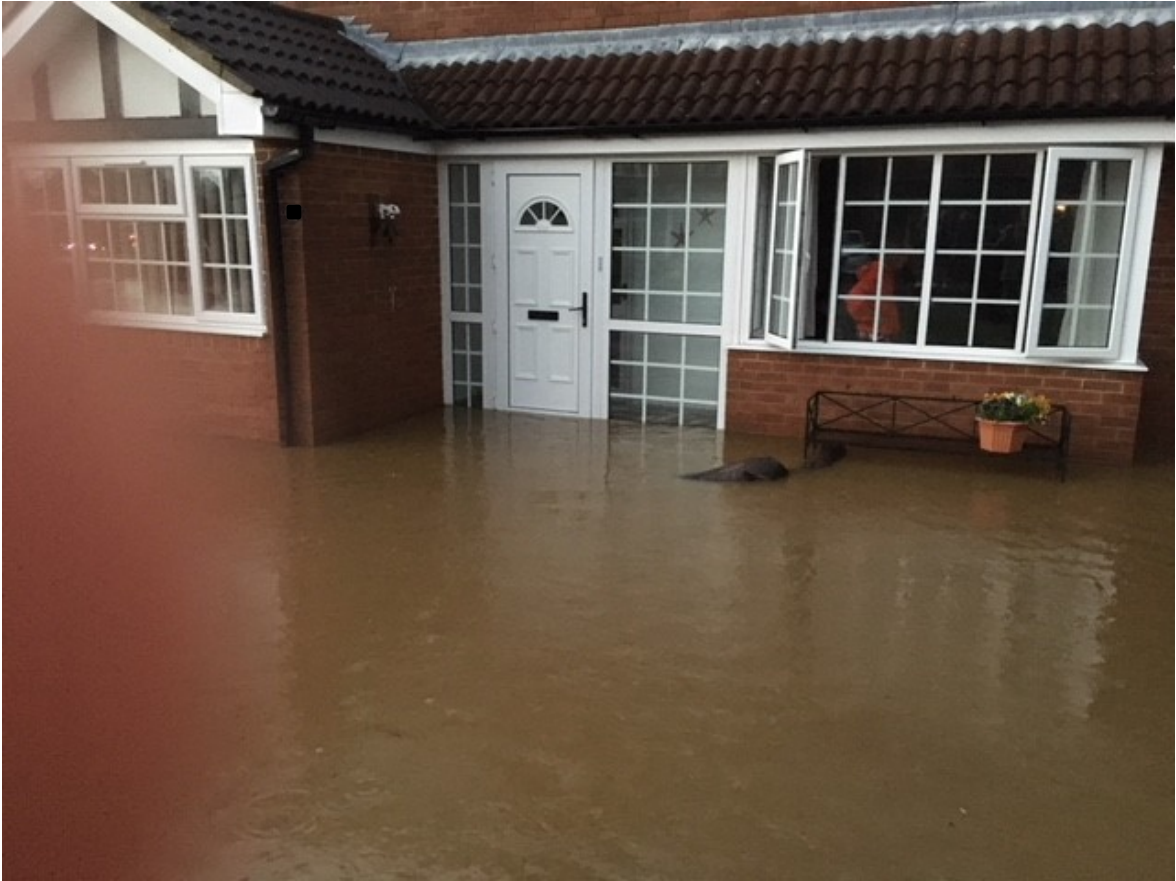
Property in Lichfield Drive

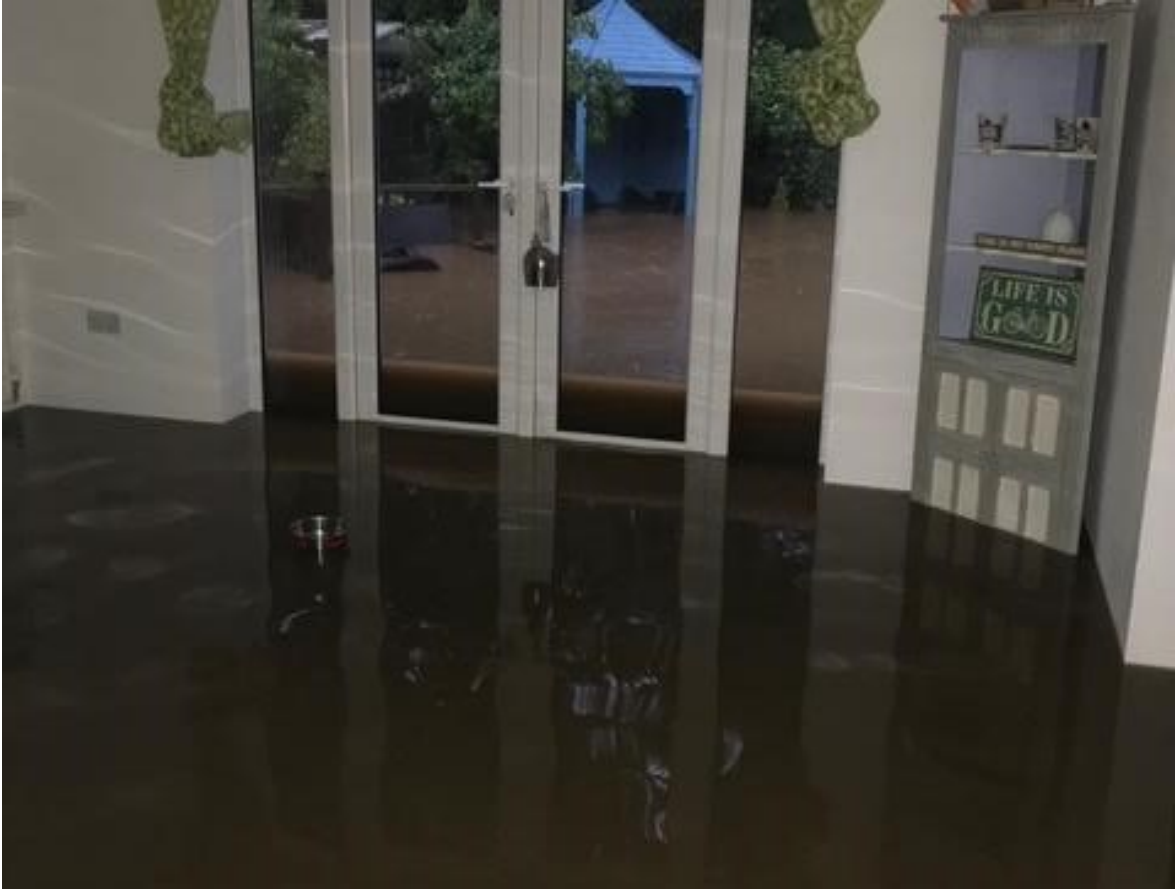
Property in Lichfield Drive

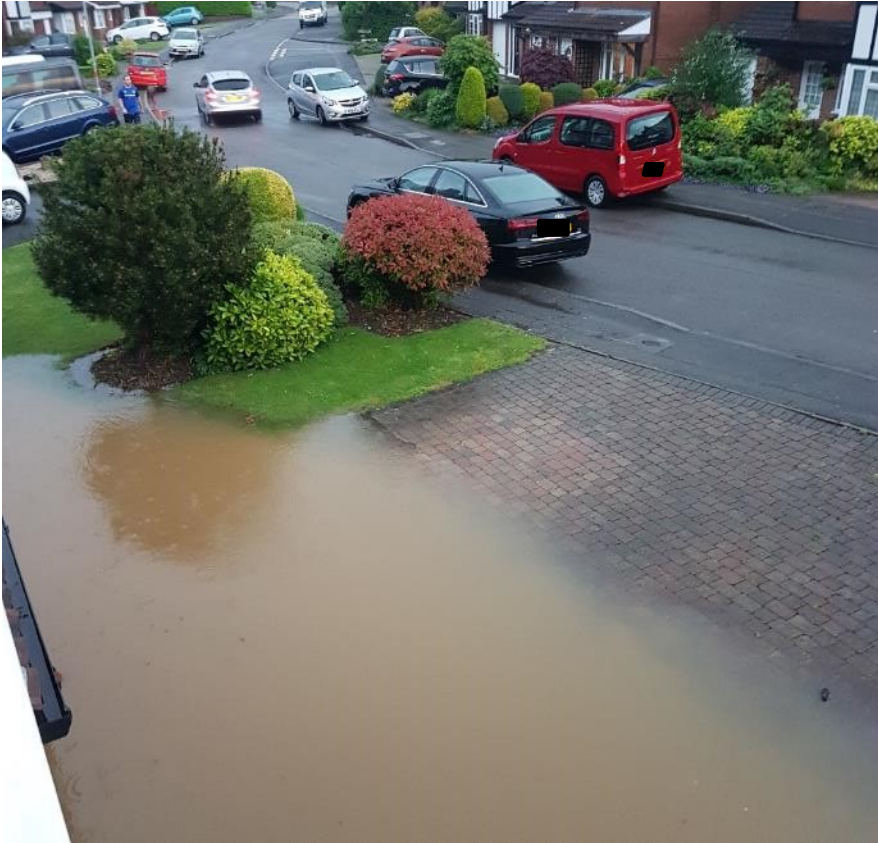
Lichfield Drive

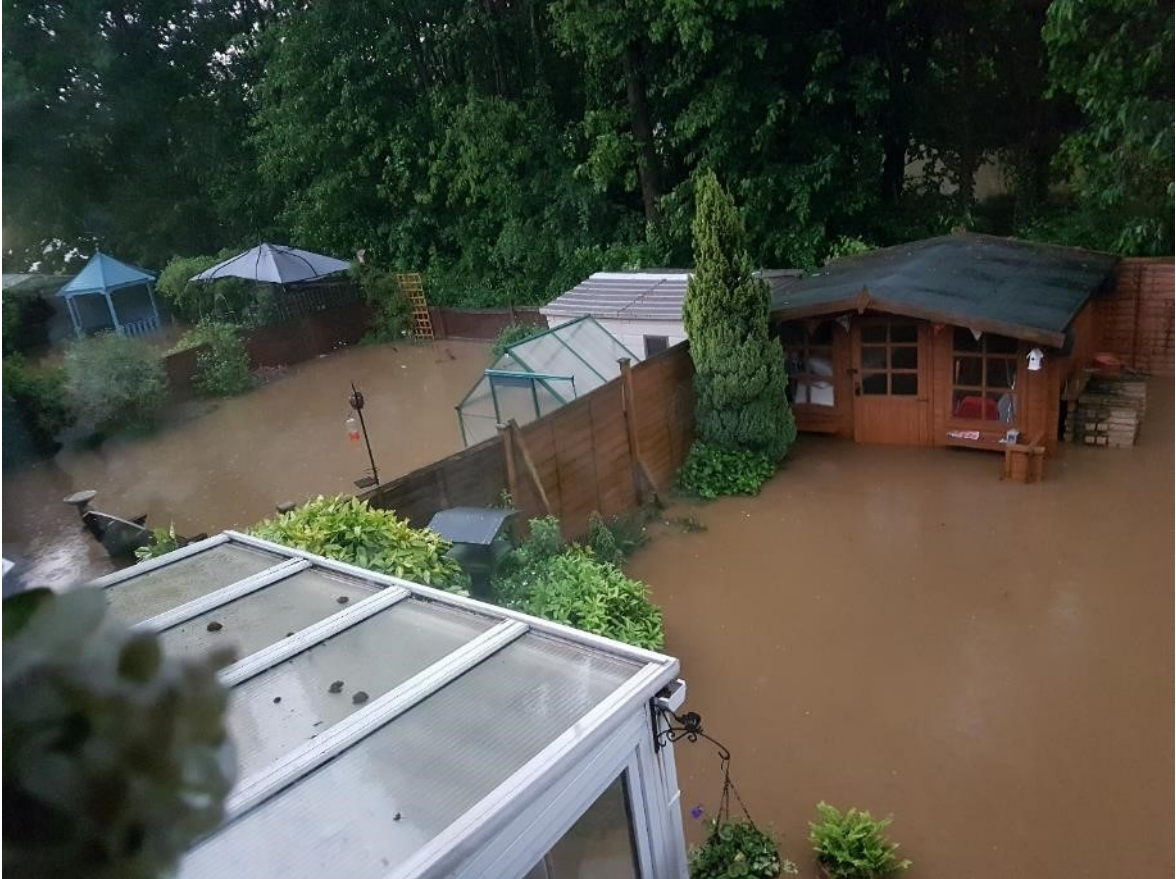
6.2.4.7 Rear garden fencing initially held back the large build-up of water. When these structures failed under the pressure of the water this then surged into the private gardens in Lichfield Drive.

Gardens to rear of Lichfield Drive

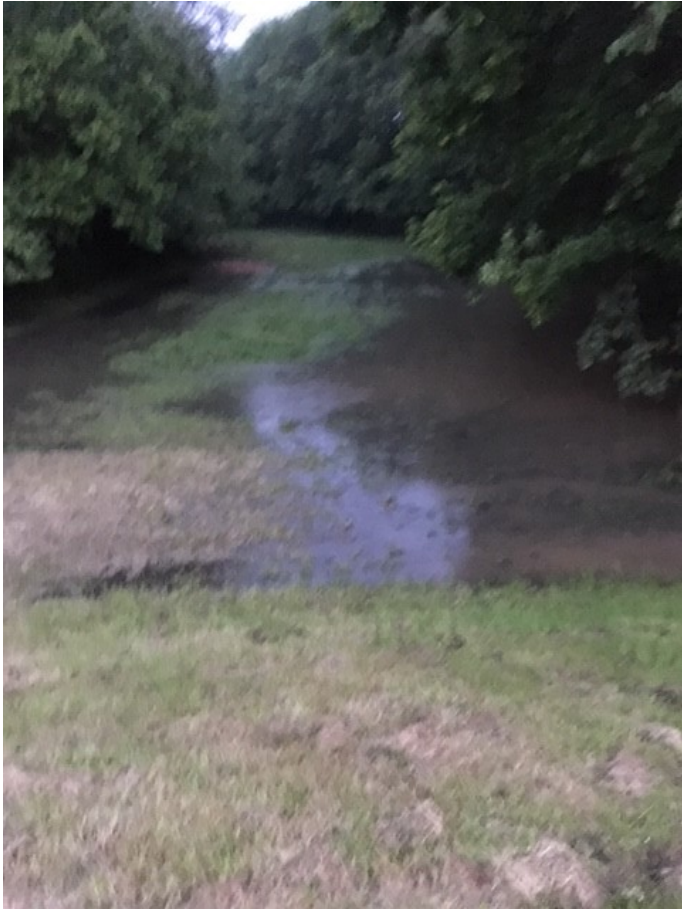
Penvale Park

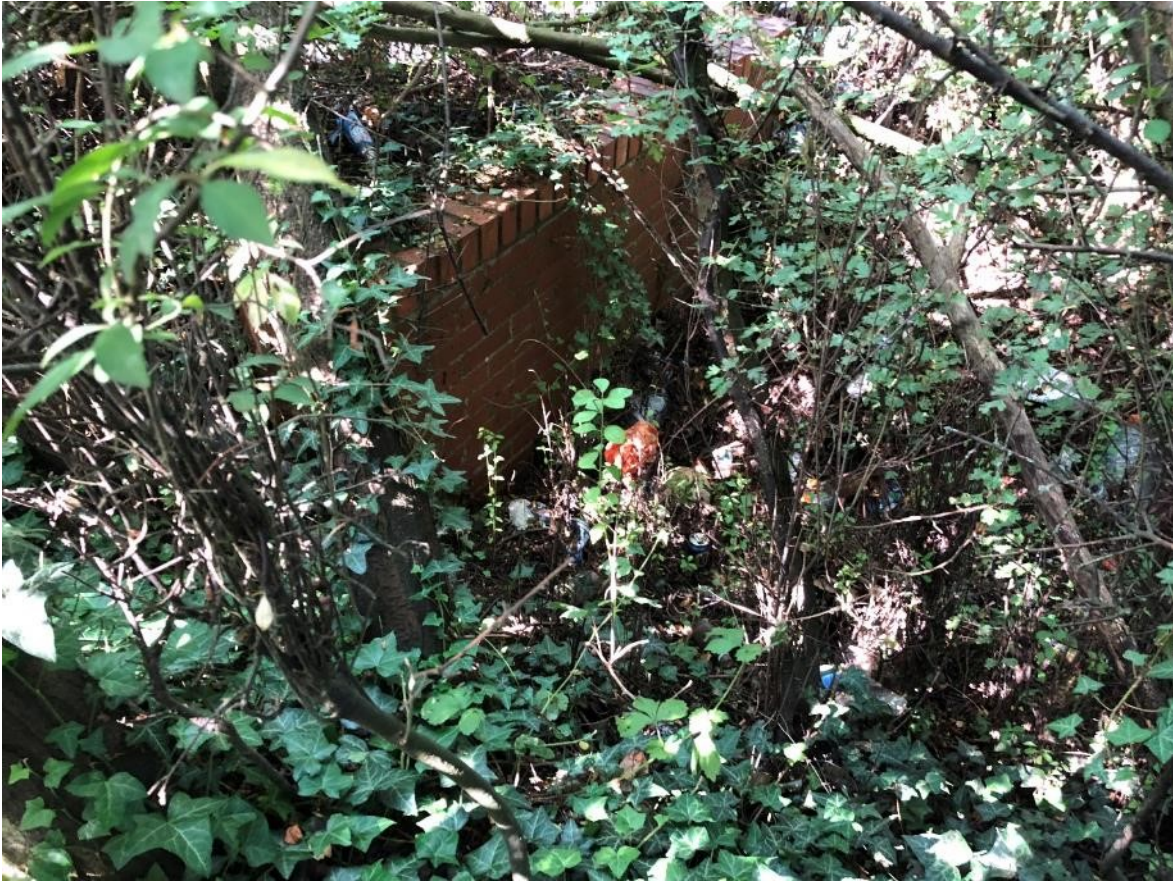
Culvert entry from Grangewood Park

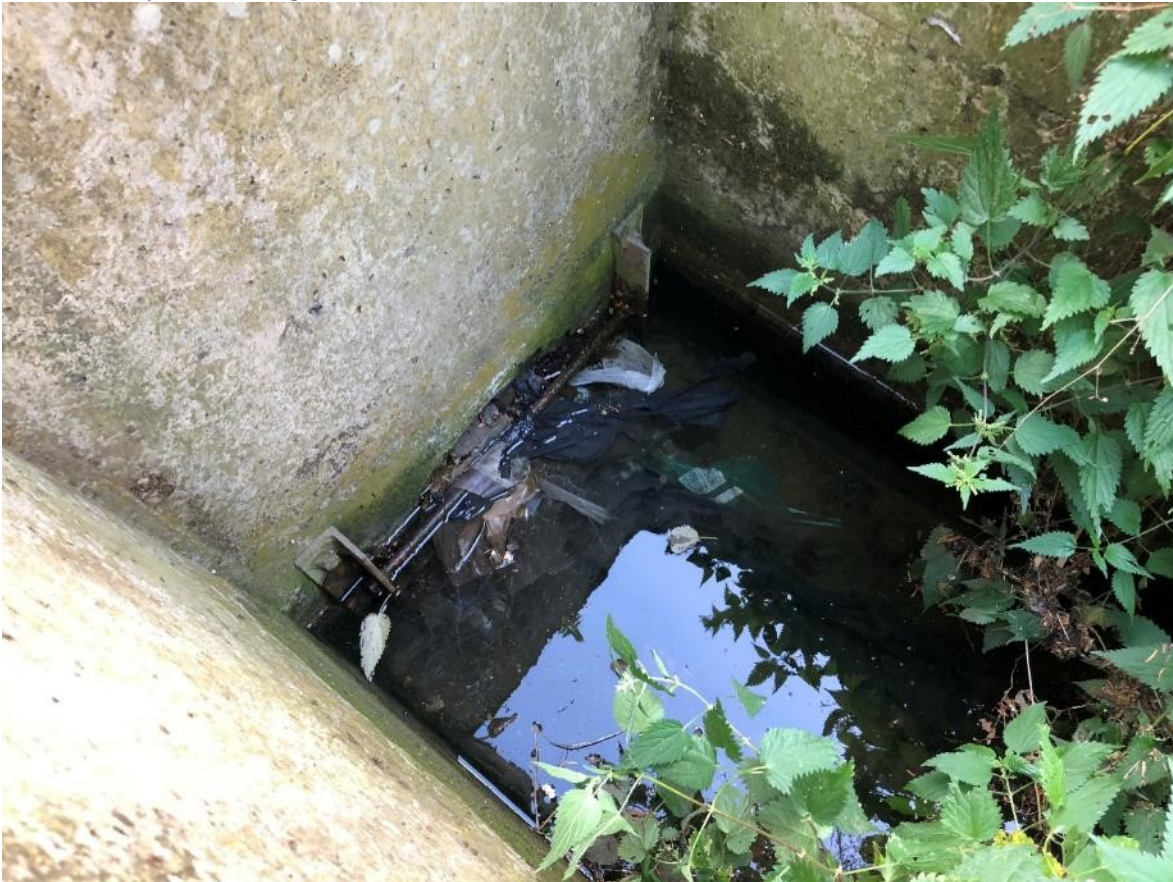
Culvert exit (south of Swallow Close)

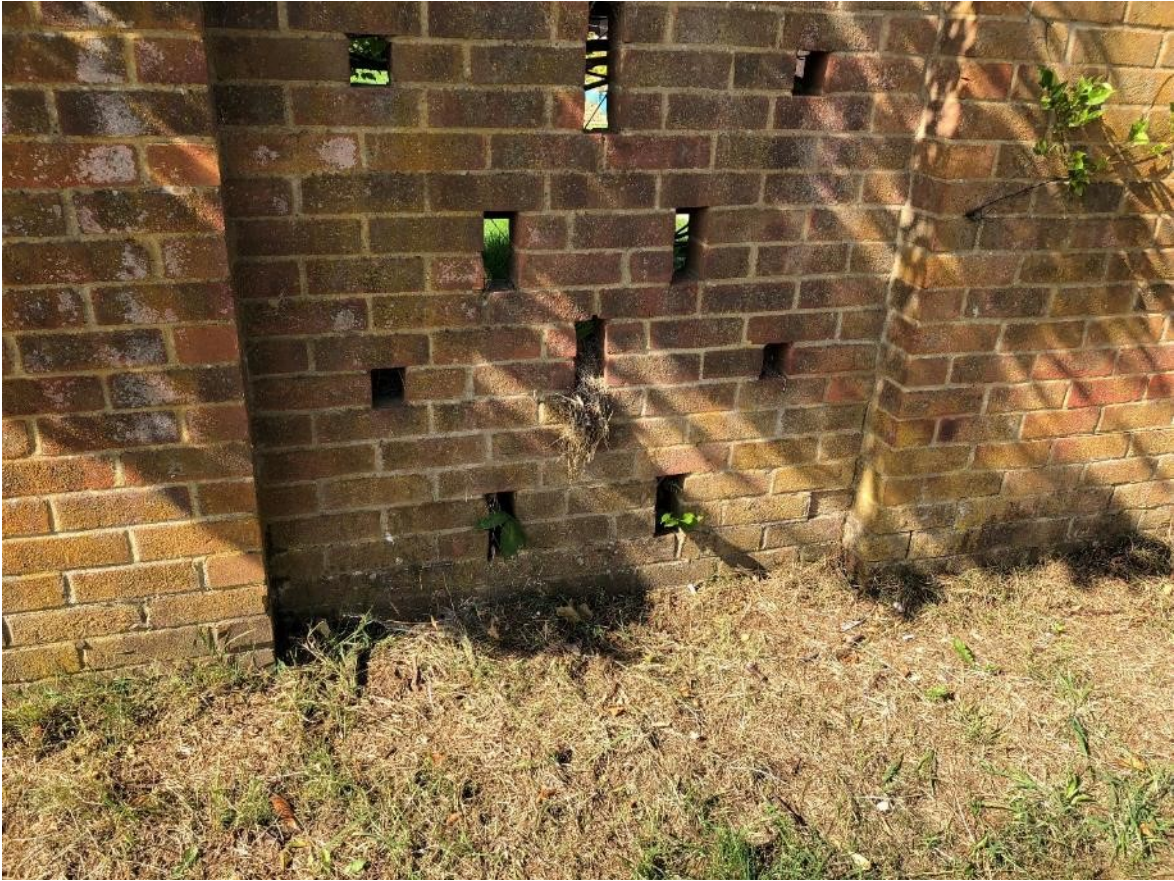
Wall to rear gardens of Swallow Close

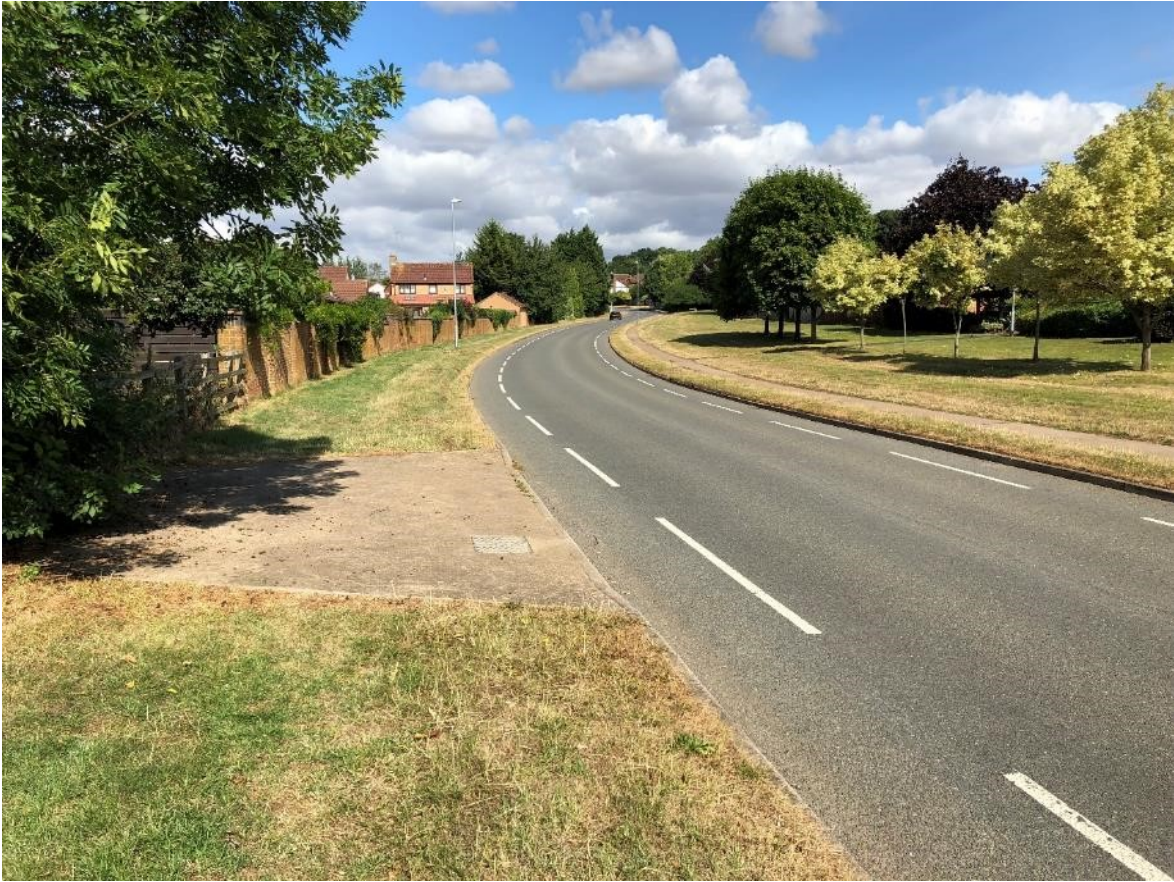
Rowtree Road.

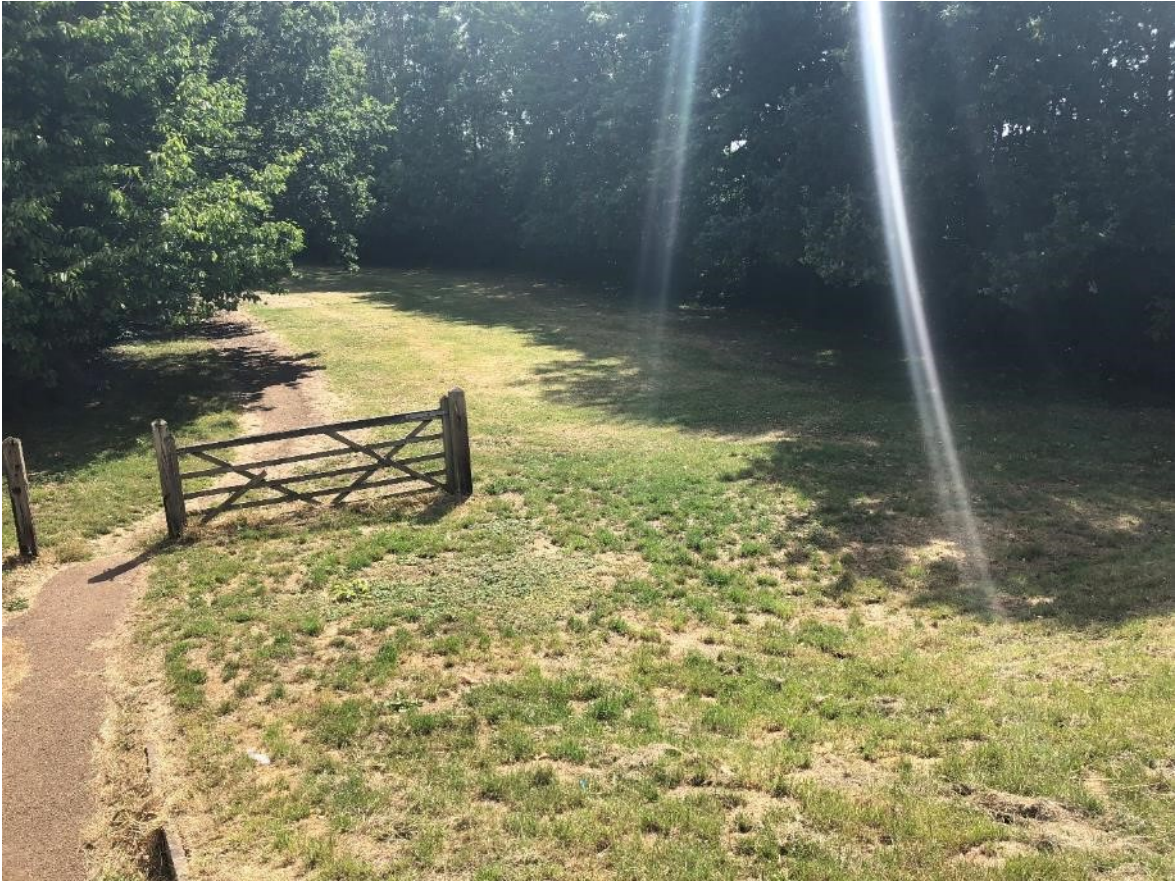
Penvale Park

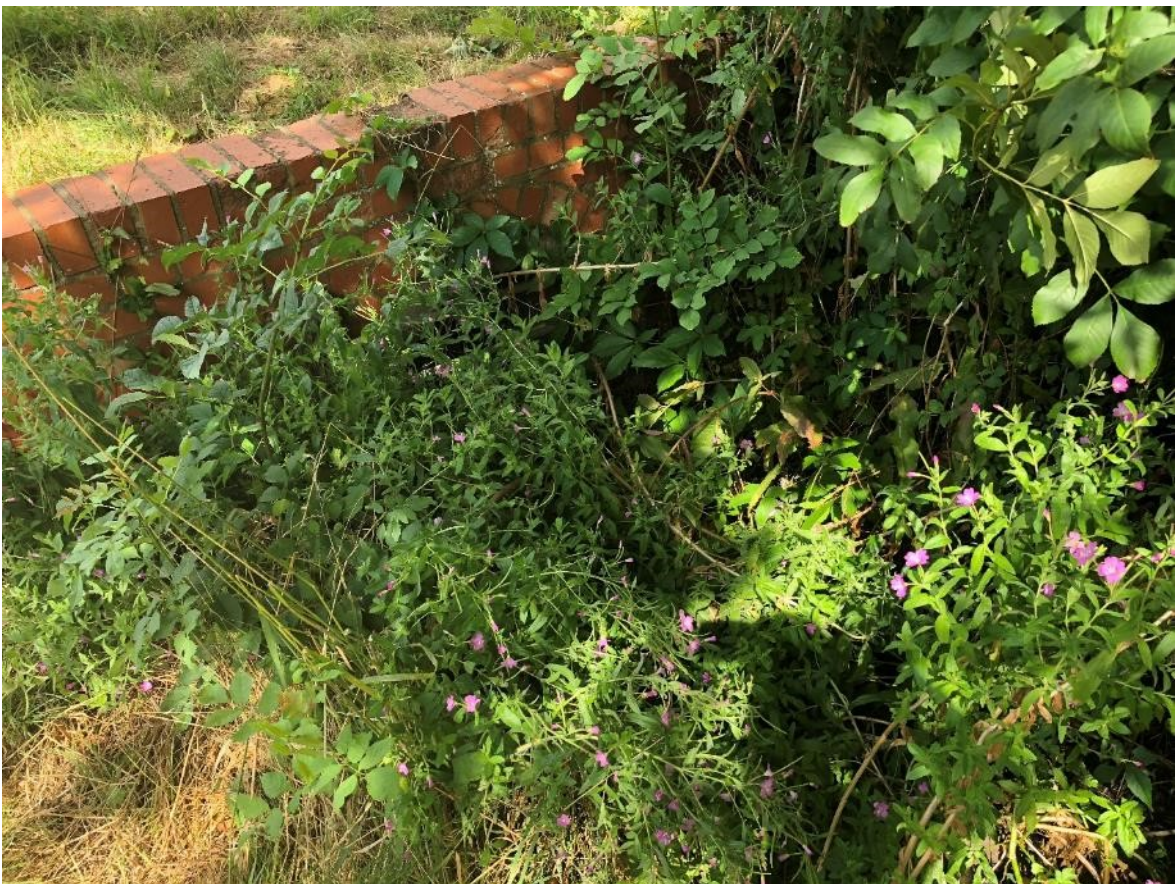
Culvert entry from Penvale Park watercourse

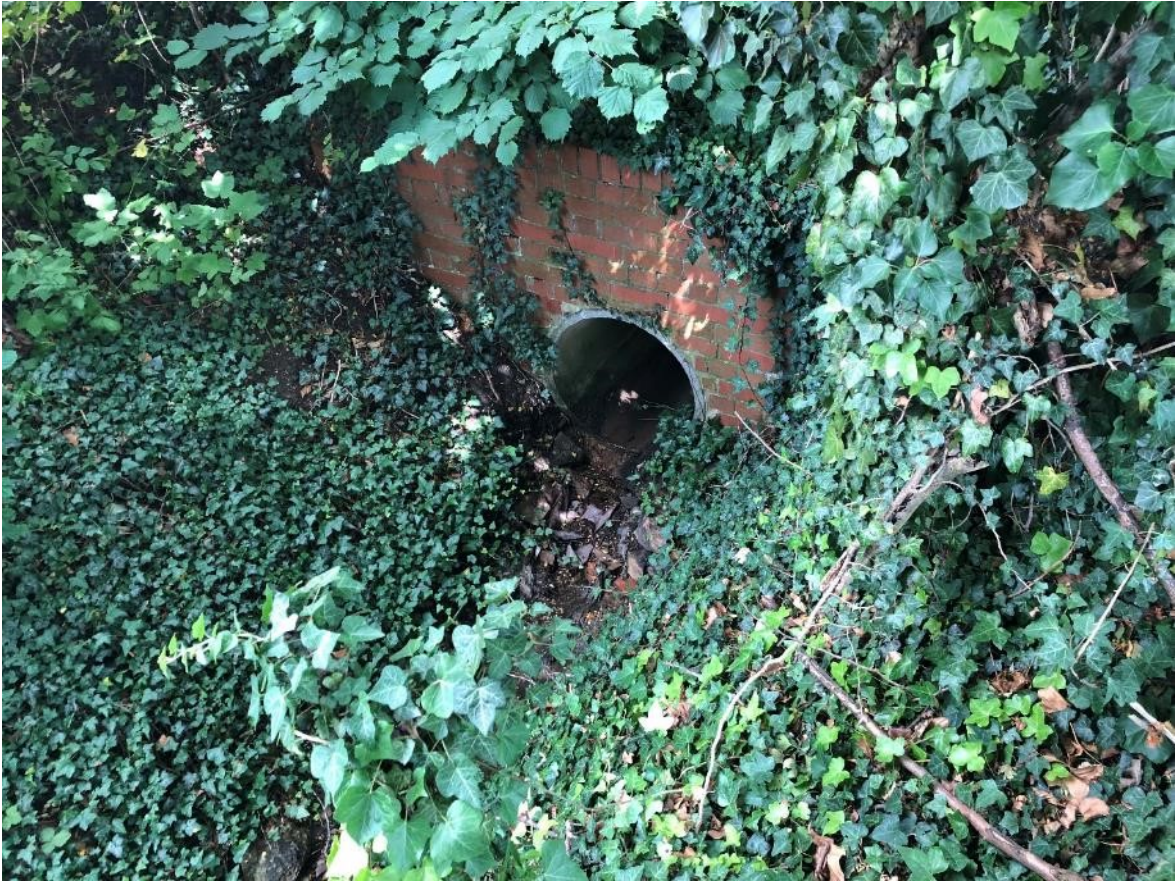
Culvert exit (Hilldrop Road)
